Re-Assessing the New York City Seismic Design Building Code

This paper addresses the need for reassessment and revision of the New York City Seismic Design Building Code to include reinforcing existing structures that were built before 1995. Although earthquakes in New York City are rare, the combination of its geology and pedology allow for little damping and the lack of adequate reinforcement in existing structures have the potential to amplify the consequences of otherwise small events. The NYC Building Code of 1995 requires new structures to be designed against seismic activity, but does not require the addition of seismic reinforcement for existing buildings. In an effort to fill this gap, a case study of Brooklyn Brownstones is presented, illustrating the concern for unreinforced masonry (URM) buildings and describing the cultural and economic

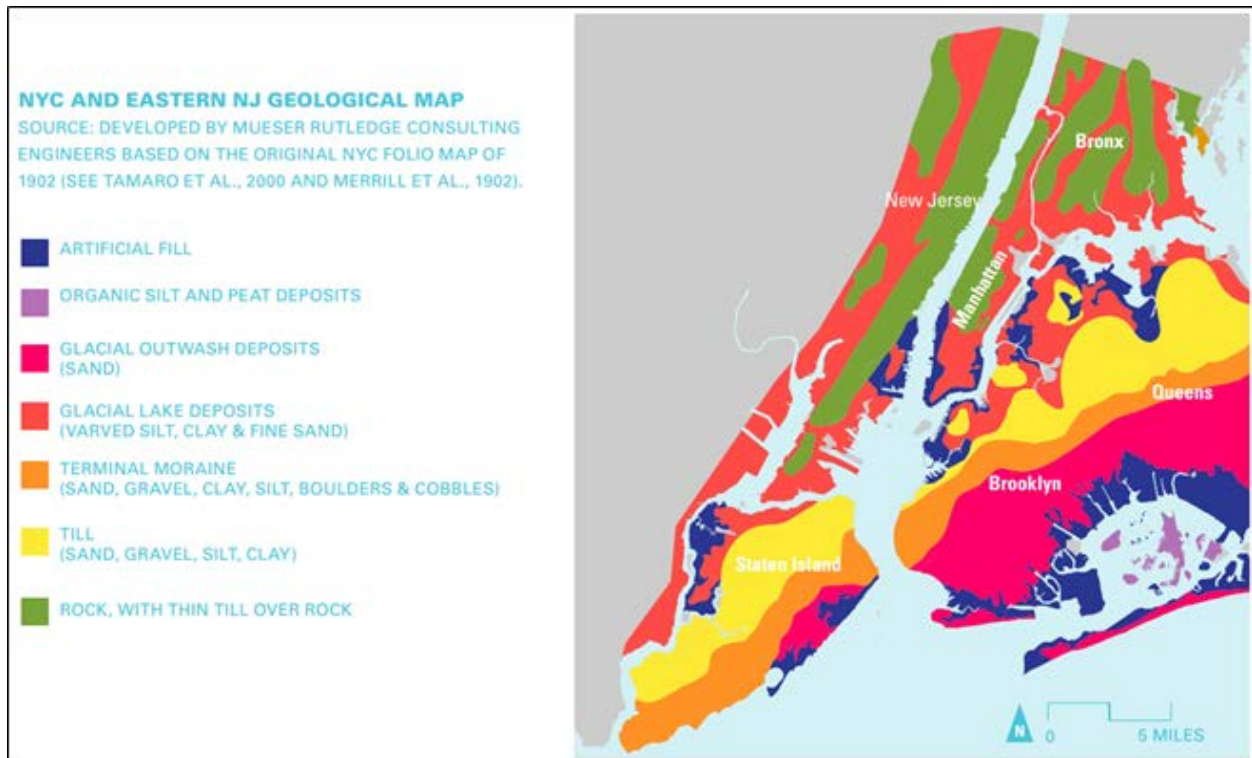
Figure 2. NYC and Eastern NJ Geological Map (Lenten, 2014)

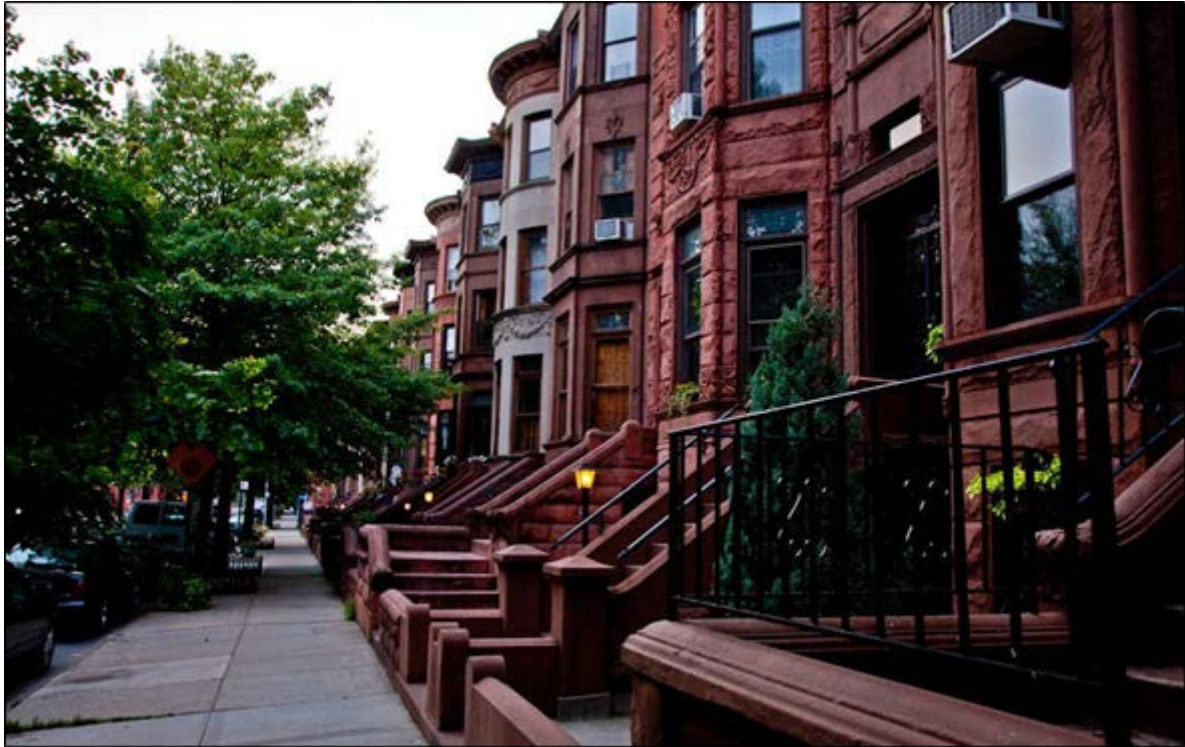
Figure 3. Brownstones in Fort Greene, Brooklyn

Today, a “Brooklyn Brownstone” refers to these brownstone-fronted buildings. They are especially susceptible to damage from earthquakes due to the nature of their construction (Sigmund et al., 2016). This is because:

- Foundations are primarily rubble, with some brick appearing after 1900.
- The exterior walls are solid brick, framed only by wood joists spanning the width of the house coupling load-bearing side walls. There is rarely proper connection between the joists and the walls, as joists are typically rested on the edges of the walls they span (Figure 4). This missing connection results in the inability of the structure to transfer horizontal loads between floors and walls.
- Although they are masonry buildings, they are unreinforced (i.e., do not have interior

bracing), and lack the strength of similar but more modern reinforced structures. Brownstones are also more prone to cracking due to cyclic in-plane shaking because they inherently have a low shear bearing capacity. In other words, repeated, reverse in-plane lateral movement is more likely to cause cracks due to the lack of interior bracing to resist it).

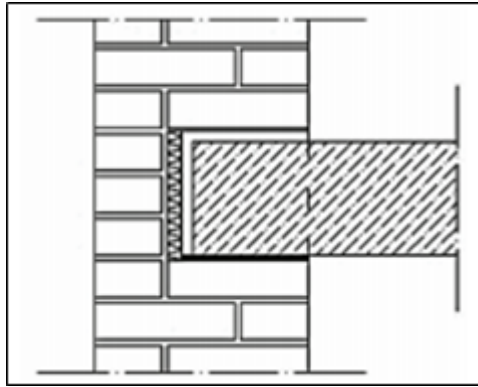
Figure 4. Typical Connection Between Joists and Walls Used in Brownstone Construction in 1860 Through 1920 (ElGawady et al., 2004)
